Influence of Soil Physical Properties on Road Pavement Failure along the Warri-Sapele Highway, Delta State, Nigeria

The study was carried out in three separate locations—Okuovwori, Okolovu, and Akuekpara—situated along the Warri-Sapele Highway in Delta State, Nigeria. The roadway features a dual-lane design composed of a lateritic subbase, a soil-cement base layer, a surface-dressed median, and an asphalt concrete wearing surface. As illustrated in Figure 1, this important route links Warri and Sapele within Delta State.

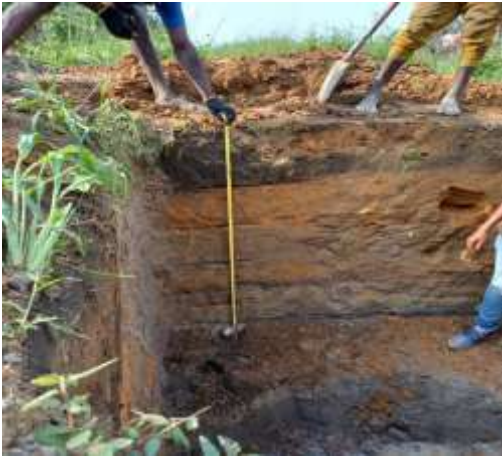
Plate 1: Pedon 1 (Okuovwori – Sand, Clay and Swamp)

Taxonomic Class	Typic Endoaquepts
Parent Material	Sand, clay and swamp
Physiographic Position	Terrace – Elevation: 16 m a.s.l.
Drainage	Poor
Vegetation/Landuse	Permanent crops – oil palm
Depth to water table	Deep (≥ 164 cm)

Horizon	Depth (cm)	Description
A	0-37	Very dark gray (10YR4/3); sandy loam; non sticky, non-plastic; fine many single grain; medium few root size; smooth clear boundary; pH 5.06
Bw	37 -64	Reddish yellow(7.5YR6/8); Sandy Clay Loam; non sticky, non plastic; loose moist and dry; medium few root size; smooth clear boundary; pH 4.97.
Bw_{2h}	64 - 92	Light brown (7.5YR6/4); Sandy Loam; medium few root size; smooth diffuse boundary; pH 4.52.
Bw₃	92 - 109	Brown (7.5YR5/4); Brown; sticky, plastic; friable moist, soft dry; fine sub-angular blocky; medium few root size; smooth diffuse boundary; pH 4.43
Bw₄	109 -125	Gray (10.5YR6/1); Sandy loam; sticky, plastic; friable moist, soft dry; medium sub-angular blocky; very few fine root size; pH 4.34.

According to Table 4, the physical and chemical characteristics of Pedon 1, located at Okuovwori, show that soil pH ranges from 4.70 to 5.06. The organic carbon content lies between 2.14 g/kg and 9.08 g/kg, while total nitrogen varies from 0.16 g/kg to 1.58 g/kg. The concentration of available phosphorus ranges between 1.68 mg/kg and 7.98 mg/kg. Calcium levels were found between 0.24 and 1.92 cmol/kg, whereas magnesium content ranged from 0.06 to 1.17 cmol/kg. The potassium content was recorded between 0.11 and 0.27 cmol/kg, and sodium levels ranged from 0.02 to 0.13 cmol/kg. Regarding soil acidity, exchangeable acidity ranged from 0.14 to 1.22 cmol/kg, and the cation exchange capacity (CEC) fluctuated between 1.45 and 3.63 cmol/kg.

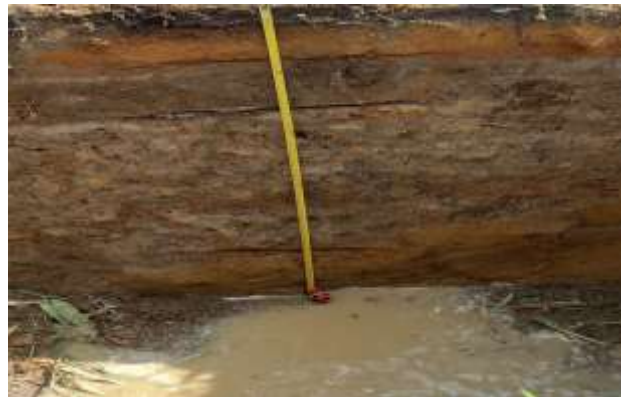
Plate 3: Pedon 2 (Okolovu – Sand, Clay and Swamp)

<i>Geographical coordinates</i> N 5.729985, E 5.752772		
<i>Taxonomic Class</i>	Aeric Endoaquepts	
<i>Parent Material</i>	Sand, clay and swamp	
<i>Physiographic Position</i>	Terrace– Elevation: 12 m asl.	
<i>Drainage</i>	Poorly drained	
<i>Vegetation/Landuse</i>	Fallow/Road	
<i>Depth to water table</i>	Deep (≥150cm)	
<i>Horizon</i>	<i>Depth (cm)</i>	<i>Description</i>
<i>Ap</i>	0 – 12	Black (10YR2/1); sandy loam; non sticky, non plastic; loose moist and dry; very fine many grain; medium few root size; smooth clear boundary; pH 5.87
<i>A</i>	12 - 23	Reddish yellow (5YR6/6); sandy loam; non sticky, non plastic; loose moist and dry; fine few grain; smooth clear boundary; pH 5.33
<i>AB</i>	23 - 38	Pinkish gray (7.5YR6/2); sandy loam; non sticky, non plastic; loose moist and dry; fine very few grain; smooth diffuse boundary; pH 4.01.
<i>Bw</i>	38 - 46	Light gray(10YR7/2); Sandy loam; non sticky, non-plastic; loose moist and dry, fine very few grain; wavy boundary; pH 4.2.

<i>Bw₂</i>	46 - 152	Strong brown (7.5YR5/6); Sandy clay loam; sticky, plastic; friable moist, soft dry; pH 4.1.

(12 cm) of the profile displays a sandy loam texture, which persists through 12 to 23 cm and also continues across 23 to 38 cm and 38 to 46 cm depths. However, from 46 to 152 cm, the soil texture transitions to sandy clay loam. The boundary separating the first and second layers appears wavy, while the transition between second and third layers is smooth and diffuse. The boundaries for layers three, four, and five are described as smooth and distinct.
